**REPORT OF INVESTIGATION**

**Surface Coal Mine**

**Fatal Slip or Fall Accident  
December 14, 2012**

**Taft Coal Sales & Associates, Inc.  
Choctaw Mine  
Parrish, Walker County, Alabama  
ID No. 01-00347**

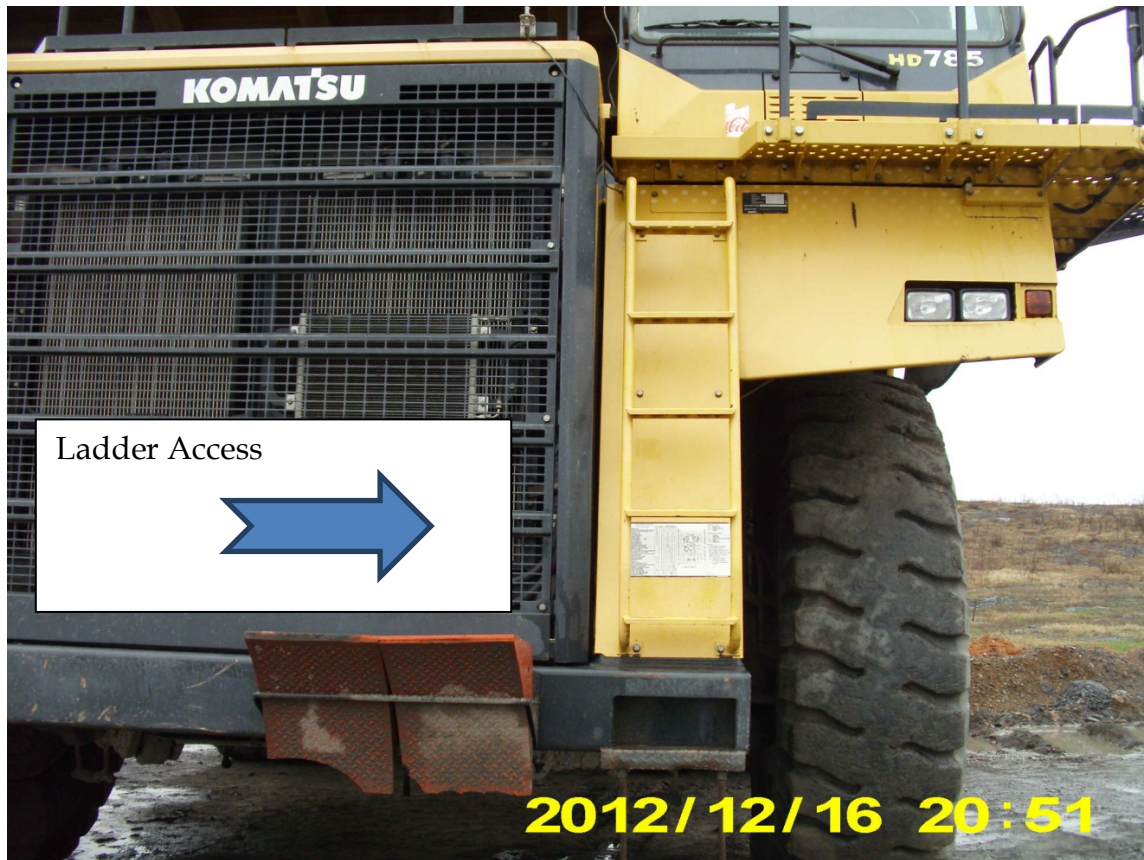
On Friday, December 14, 2012, at approximately 2:50 p.m., a 52-year-old rock truck operator was injured while ascending an access ladder to the operator's cab of a Komatsu HD 785 rock truck, Company No. 336. The victim, while ascending the access ladder, slipped and fell to the ground landing on both feet, and then fell over onto his back. The victim was treated on site by medical personnel and then transported by ambulance to Walker Baptist Medical Center in Jasper, Alabama. Due to medical complications he was later transported to University of Alabama Hospital's Trauma Unit in Birmingham, Alabama. The victim died from the injuries sustained in the fall on December 28, 2012.

Inspection of the boarding system on the truck indicated no mechanical failures and no slipping hazards present.

Evidence obtained through interviews indicates the victim fell while ascending the access ladder. An inspection of the ladder/mounting system was conducted and no hazards or defects were found.
